Tree Assessment and Forest Management Plan for the Cypress Cove II Landscape Maintenance District

March 2025

The City of Marina and the Residents of Cypress Cove II Landscape Maintenance District

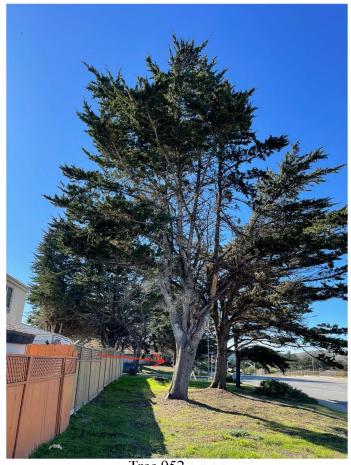
Tree 952.

952	Hesperocyparis macrocarpa	Monterey Cypress	24	30	18	2	Fair	DW, HD, EH
953	Hesperocyparis macrocarpa	Monterey Cypress	32	40	24	4	Poor	HD, CDB
954	Hesperocyparis macrocarpa	Monterey Cypress	12	15	9	4	Fair	CDB, DW, recommended to raise canopy
955	Hesperocyparis macrocarpa	Monterey Cypress	11	14	8	2	Fair	DW, S-SD, EH, ML
956	Hesperocyparis macrocarpa	Monterey Cypress	8	10	6	4	Poor	CDB
957	Hesperocyparis macrocarpa	Monterey Cypress	23	29	17	1	Fair	HD
958	Hesperocyparis macrocarpa	Monterey Cypress	40	50	30	1	Fair	S-DW, S-HD
959	Hesperocyparis macrocarpa	Monterey Cypress	35	44	26	1	Fair	DW, HD
960	Hesperocyparis macrocarpa	Monterey Cypress	6	8	5	1	Poor	DW, HD, SD, LN
961	Hesperocyparis macrocarpa	Monterey Cypress	18	23	14	1	Fair	DW, HD, LN
962	Hesperocyparis macrocarpa	Monterey Cypress	17	21	13	1	Fair	DW, HD, Tree is approx. 2 feet from fence line
963	Hesperocyparis macrocarpa	Monterey Cypress	18	23	14	1	Fair	DW, HD, Tree is approx. 2 feet from fence line

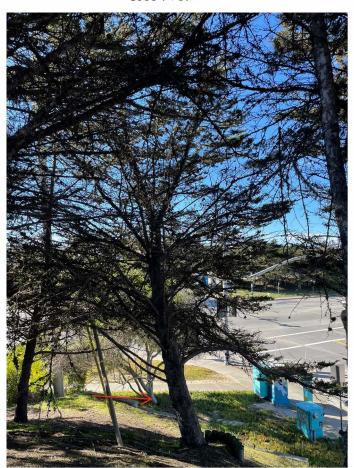
Tree 978.

978	Hesperocyparis macrocarpa	Monterey Cypress	16	20	12	4	Fair	DW
979	Hesperocyparis macrocarpa	Monterey Cypress	20	25	15	1	Fair	DW, HD
980	Hesperocyparis macrocarpa	Monterey Cypress	9	11	7	1	Dead	Recommended for removal
981	Hesperocyparis macrocarpa	Monterey Cypress	14	18	11	4	Poor	LN, SR
982	Hesperocyparis macrocarpa	Monterey Cypress	33	41	25	2	Fair	DW, HD
983	Acacia melanoxylon	Australian Blackwood	11	13	8	3	Poor	D, Tree recommended for removal
984	Hesperocyparis macrocarpa	Monterey Cypress	18	23	14	4	Fair	SL-DW
985	Hesperocyparis macrocarpa	Monterey Cypress	30	38	23	4	Fair	LN, SR
986	Hesperocyparis macrocarpa	Monterey Cypress	6	8	5	2	Fair	DW, HD
987	Hesperocyparis macrocarpa	Monterey Cypress	48	60	36	4	Poor	D, HD
988	Hesperocyparis macrocarpa	Monterey Cypress	6	8	5	1	Fair	DW, HD, PRC
989	Hesperocyparis macrocarpa	Monterey Cypress	20	25	15	1	Fair	DW, HD, PRC
990	Hesperocyparis macrocarpa	Monterey Cypress	26	32	19	4	Fair	HL, DW
